Subject: Trip Report for Cape Hatteras National Seashore, March 14-16, 2000

PURPOSE: The purpose of this trip was to evaluate the network of drainage ditches on the southeast part of Hatteras Island and discuss flooding problems at the campground and on interdunal roads.

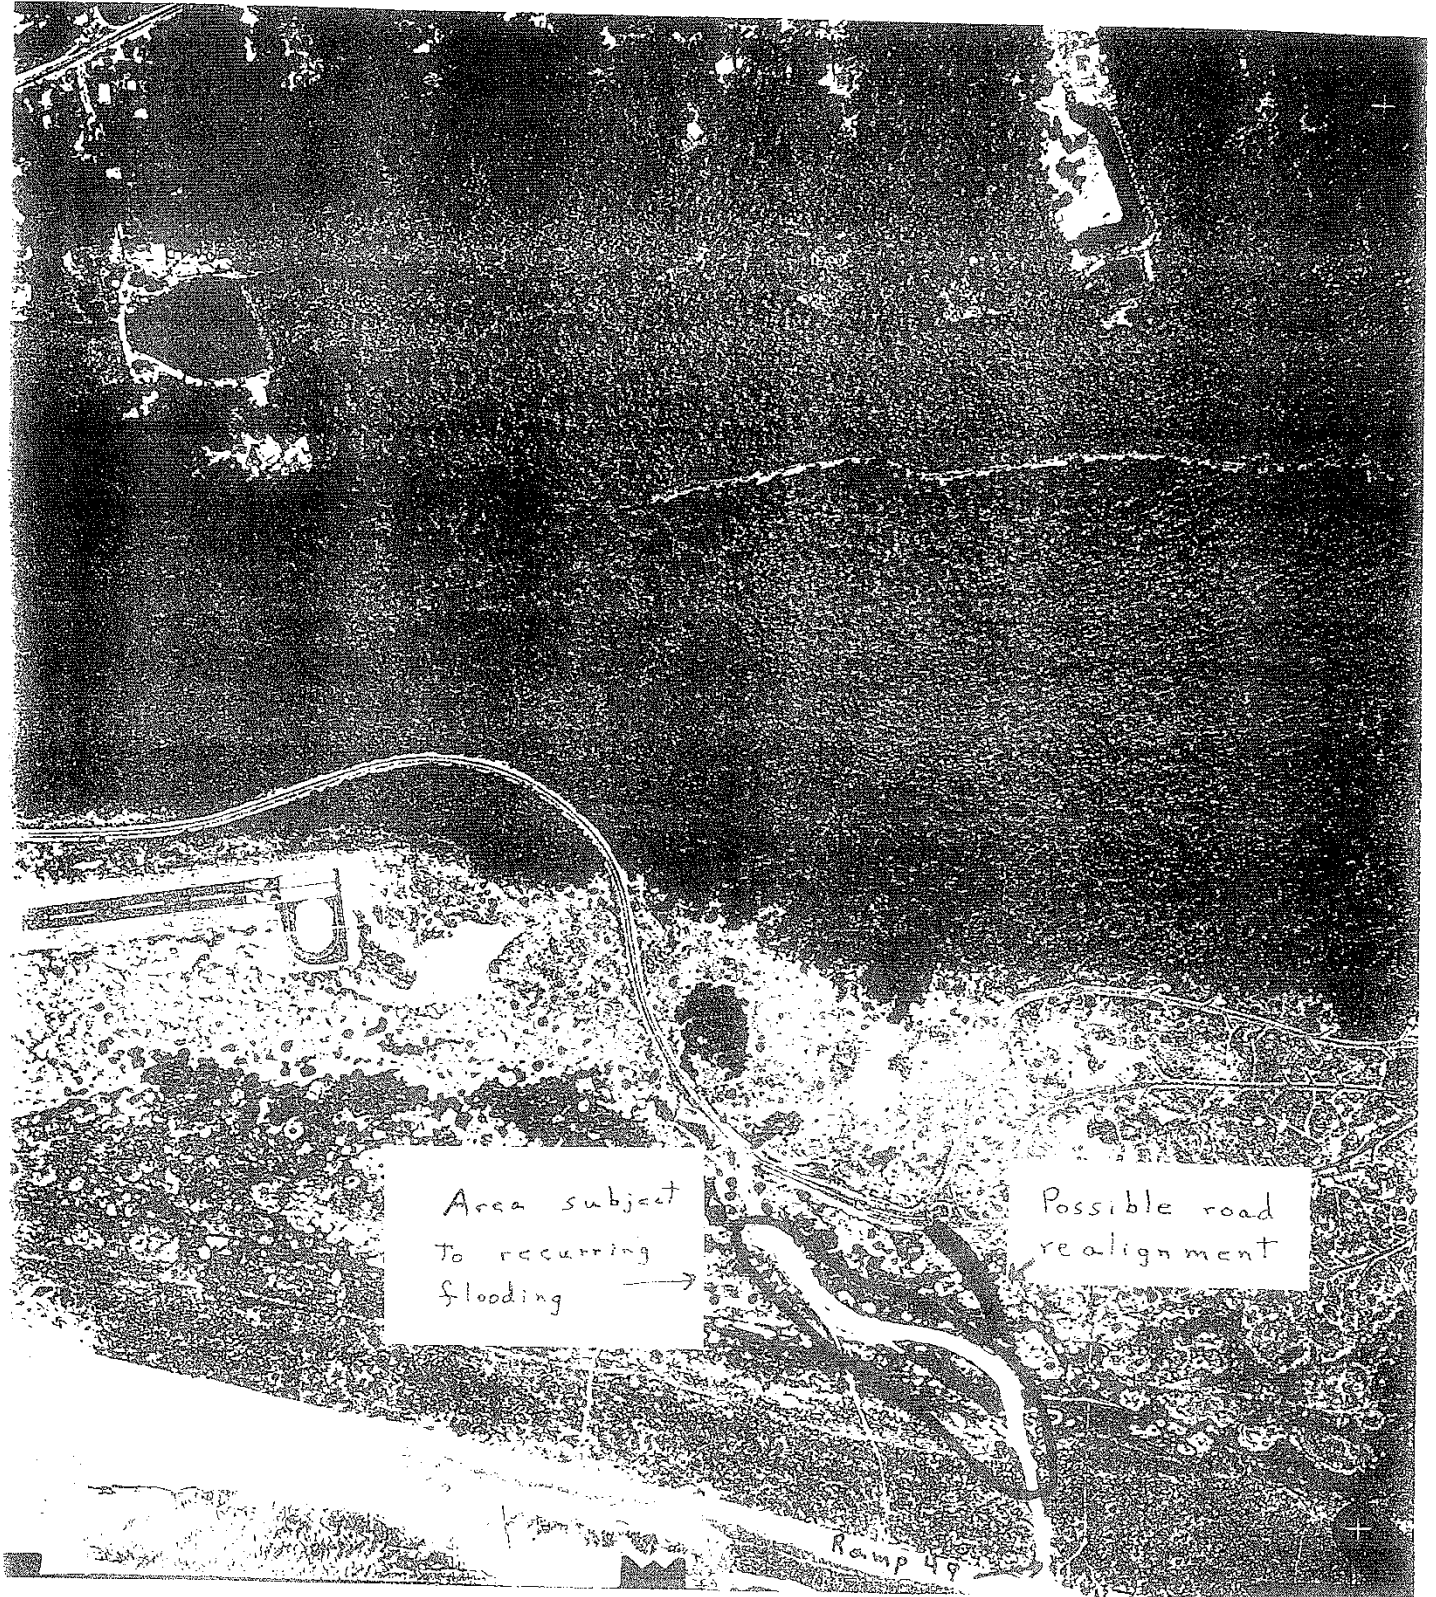
Ramp 49

Beach access via Ramp 49, south of the Frisco Campground, is sometimes difficult due to flooding of the road in the interdunal area. The access road to the beach is routed through a low-lying interdunal area between the campground and the beach access at Ramp 49. During wet periods when the water table is high, this area is naturally flooded due to the high water table conditions and the low-lying topography. An attempt could be made to reroute the road on higher ground, but it must almost certainly pass through some low-lying interdunal areas. Continued driving across any route makes the disturbed sand more susceptible to erosion, eventually resulting in lower elevation and flooding along the new route. Other options that are more compatible with periodic, high water tables include hauling in sand or other permeable fill to raise the elevation of the road in low-lying areas or closing beach access in this area when the road is flooded. Road closure is strictly a park management call and its feasibility cannot be assessed here. Elevating the road surface on a porous fill would be effective and result in little or no interference with natural processes. Any attempt to raise the elevation of the roadway through the interdunal area must

Area subject
to recurring
flooding →

Possible road
realignment

include some type of framework, such as posts or beams, to contain the fill material to the elevated portion of the roadway. Otherwise, continued driving across unconsolidated fill material would result in the fill being pushed to the side of the road, eventually working its way back to lower topographic elevations.

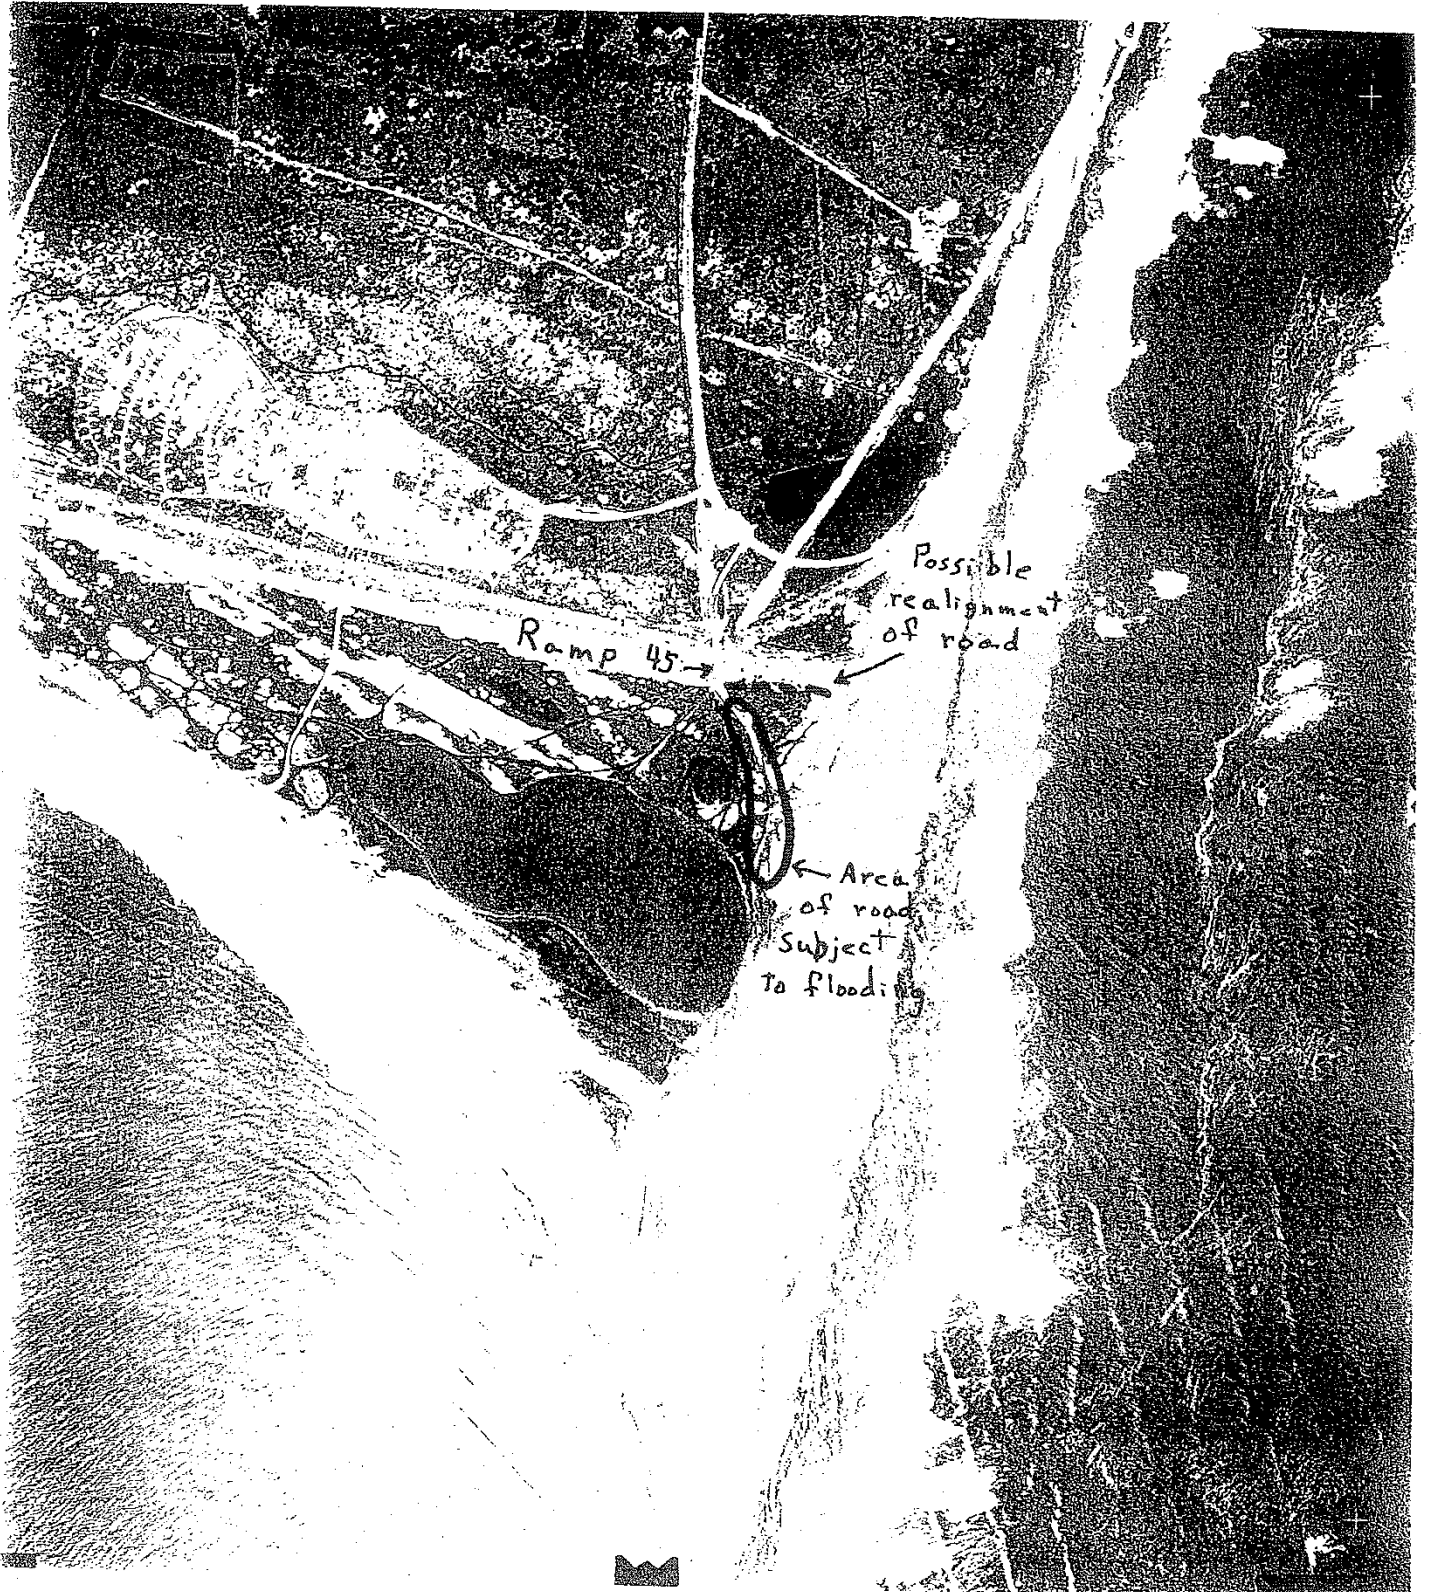
The roadway south of Ramp 45 is periodically flooded where it passes through a low-lying area northeast of a large pond. This flooding is the result of high water table conditions following heavy rainfall. Flooding problems in this area could be alleviated by building an elevated roadway through the low-lying area, as described above. There may also be an opportunity to reroute the road to avoid the low-lying area by routing the road due east, immediately south of the ramp, and accessing the beach further north than the current access. Detailed surveying would be needed to determine if such an alternate route would provide adequate topography to alleviate flooding of the roadway.

There was some discussion about whether opening the floodgate to drain ditches around the campground could alleviate flooding south of Ramp 45. Flooding at Ramp 45 is caused by high water table conditions. Opening the floodgate would lower the water table in the vicinity of the campground north of Ramp 45, but it would still take some time for the water table south of Ramp 45 to be lowered by seepage of ground water to the ocean. That is, we could intercept ground water upstream and prevent it from flowing toward Ramp 45. Flooding south of Ramp 45 would still be a problem, although for shorter periods. There would be additional environmental impacts associated with opening the floodgate for longer time periods to intercept this "upstream" ground water from flowing south toward the Ramp 45 area.

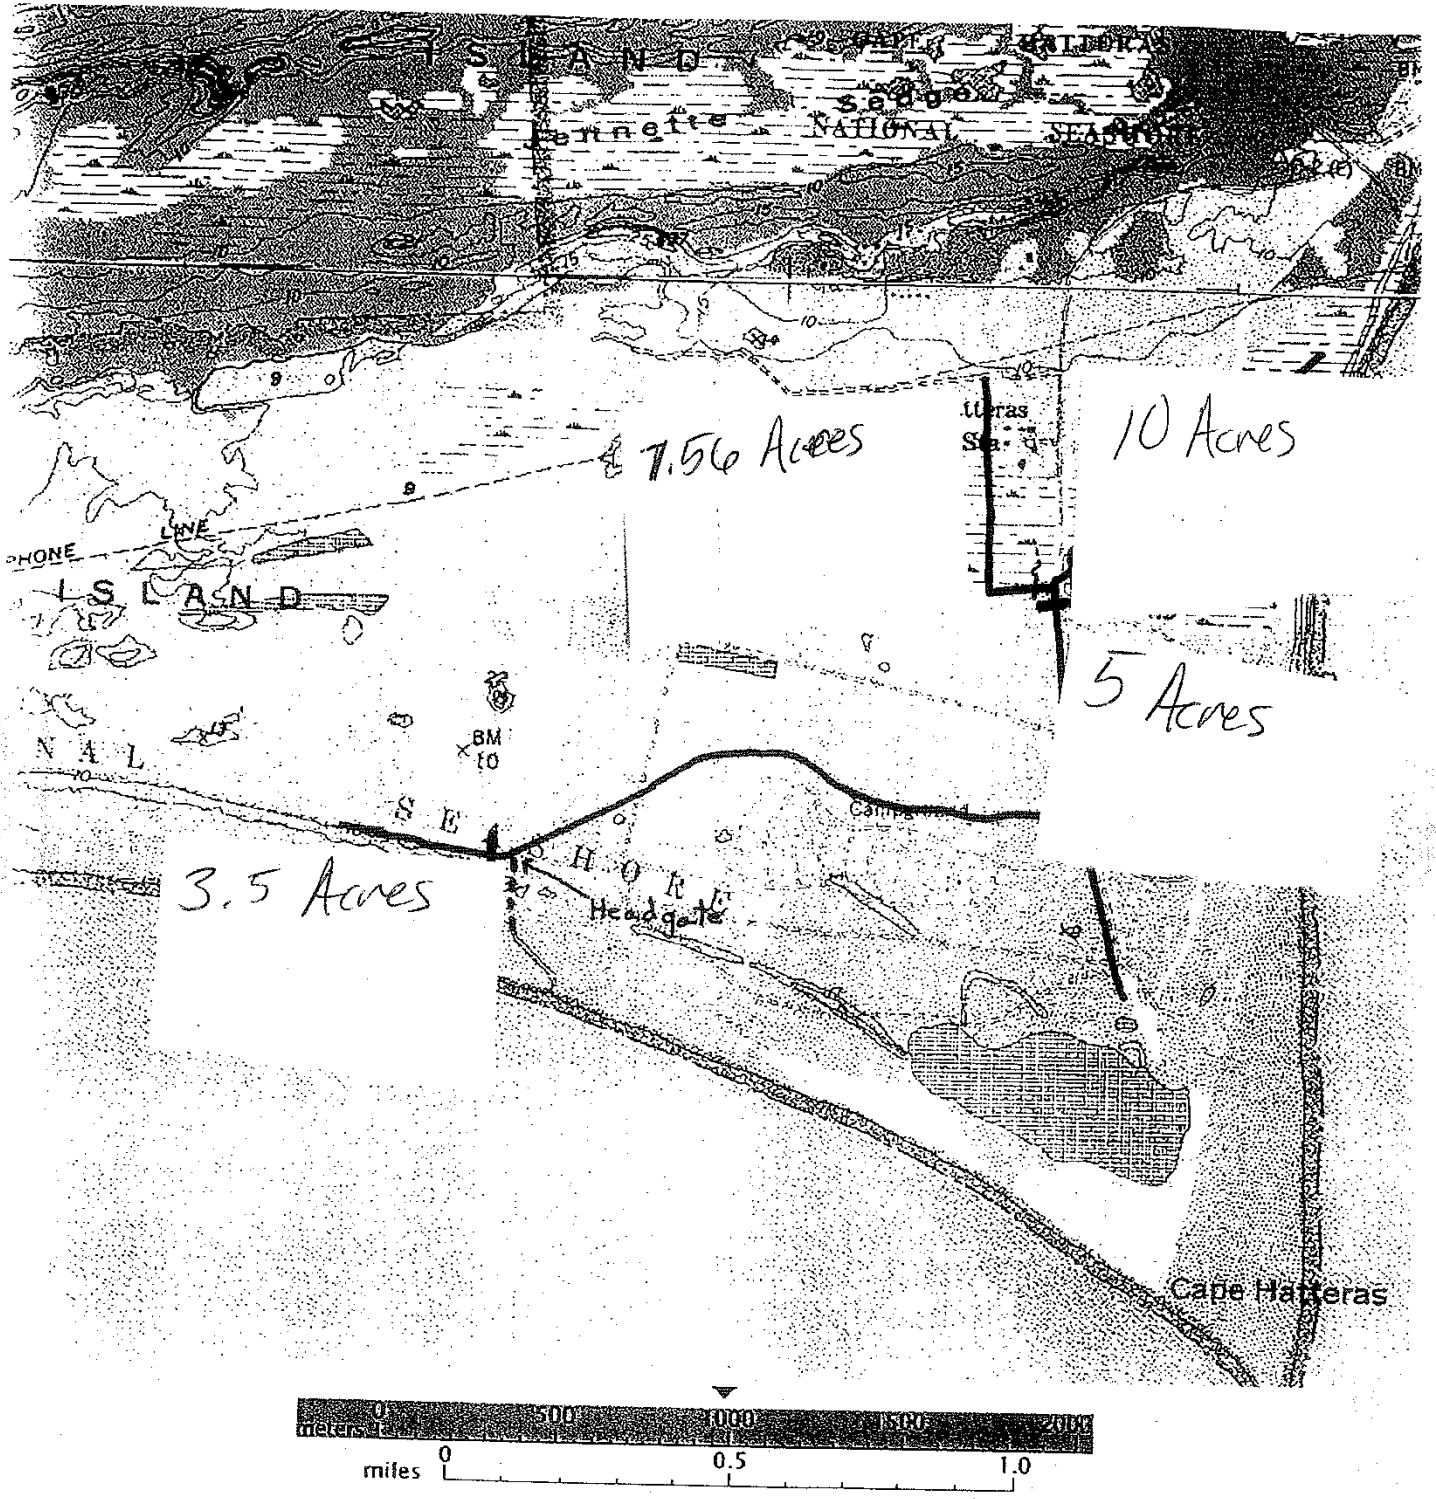
The southeast part of Hatteras Island, that part south and southwest of the lighthouse and in the vicinity of the campground, has a network of drainage ditches. These ditches function to drain water from the wetlands and the campground during wet periods when high water table conditions would otherwise result in flooding. Outflow from the drainage ditches is controlled by a headgate where the ditches enter a culvert running under the dune field to the ocean. The headgate is located about half a mile west of the campground. When flooding occurs in the campground area, the headgate is opened, allowing water to drain to the ocean. The network of drainage ditches may be

far more extensive than is needed to drain water from the campground area. For example, it appears that the wetland areas west and east of the ranger station and possibly the area near Horseshoe Pond are being drained. The drainage ditches extend some distance west from the headgate, draining wetland areas where there is no development or infrastructure that could be affected by flooding. Draining these areas causes an unnecessary impact on park resources and increases the time required to drain water from the campground area. If the network of drainage ditches were limited to the campground area only, drainage would occur much faster.

Existing drainage ditches near Cape Point Campground and proposed dam locations

The drainage ditch extending west of the headgate should be dammed. Allowing this area to flood would result in restoration of natural hydrologic conditions. And eliminating this area from the drainage network should reduce the amount of time necessary to keep the headgate open.

Dams could be placed in the ditch along the road between the ranger station and the campground entrance to eliminate draining a large area north and east of the campground. Proposed dam locations include: the box culvert under the road south of the ranger station, the ditch on the west side of the road just south of the box culvert, and the ditch on the west side of the road just north of the campground entrance. Placing dams in these areas should effectively eliminate draining the wetland areas east of the road and south of the lighthouse. It should also greatly reduce drainage from the wetland areas west and south of the ranger station on the west side of the road.

Dams could be constructed by dumping several truckloads of fill material or sandbags in ditches at selected locations. The fill material could quickly and easily be removed with a backhoe, restoring the drainage network to its current configuration, if undesired impacts occur.
