Resource Advisor - Final Report Hurricane Irene Cape Hatteras National Seashore

Incident Dates: Begin August 23, 2011 - September 10, 2011
Incident Name: Hurricane Irene
Incident Number: NC-CHP-110001
Location: Cape Hatteras National Seashore 35.212 N, 75.531 W
Incident Commander: Zeph Cunningham

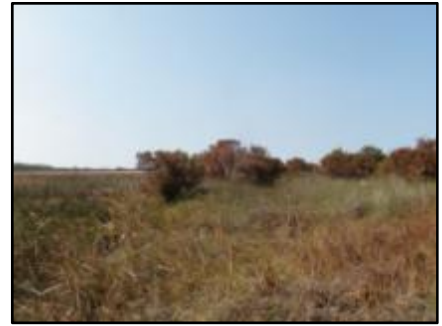
Marshes on Bodie Island

Observations: These areas have sustained salt water inundation and most plant matter is salt burned. There was no visible *Eleocharis* sp. observed. Populations of *Hudsonia tomentosa* and *Lechea maritime* var. *virginica* in open dunes remain intact.

Overall Recommendations: Considering installing salinity stations to monitor how fast the salinity drops back. These were designated significant due to the unique freshwater ponds.

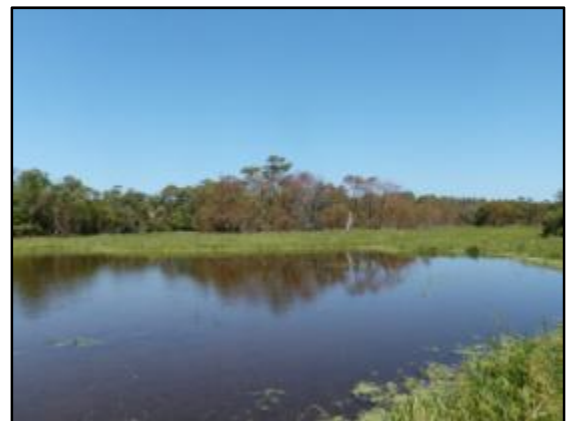
Pond in Buxton Woods

Overall Observations: The area was surveyed for pondweed (*Potamogeton illinoensis*). At a recent site visit this plant was located however, the pond was lower at the time of the visit. The east end of the trail sustained more wind and salt damage to all species of trees however this did not warrant concern on part of resource specialists.

Overall Recommendations: The area should be monitored for the invasion of the non-native *Phragmites* and beach vitex.

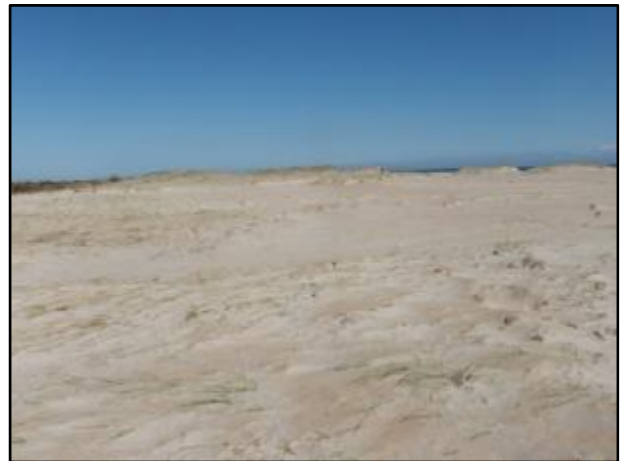
Overwash on Hatteras Sand Flats

Overall Observations: This site underwent the most change as the result of hurricane Irene. Previously, the area had a significant dune component with heavy vegetation cover. Following the storm, many of the dune areas have been over washed by sand. Threatened species (*Trichostema spp.*), previously abundant in the dunes, has been buried by overwash. Significant salt burn was seen making some vegetation unrecognizable. Many pictures were taken at this location. Upon evaluation of aerial photos, it appears a significant portion of the landmass on the western tip was removed during the storm.

Overall Recommendations: The extent of the changes to the landscape will be best quantified through aerial photography. This area should be monitored for use by shorebirds for nesting and foraging. While there were many changes to the dunes in this area, there are still many dunes left allowing for potential habitat for the plant species of concern. The area should be monitored for the invasion of the non-native beach vitex. *Trichostema* should be monitored for recovery from overwash. This is also a historic amaranth site and should be surveyed next year.

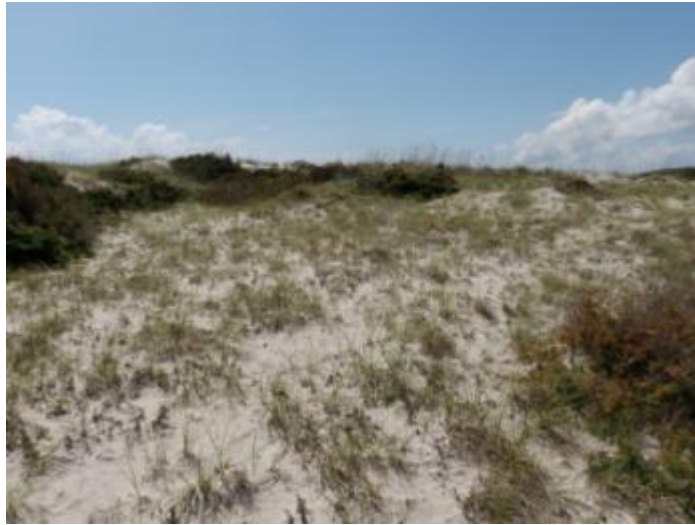
Overall Observations: The only area significantly impacted in the central portion of the island was the overwash where the dune replenishment was completed by the NCDOT. There are still several vegetated dunes intermixed with the repaired dunes. On September 8th, the surge from Katia overwashed the road a second time. Currently the extent of the flooding and washout is unknown, as is the proposed clean-up plan. Ramp 67, a previously known site for *Trichostema spp.1*, was resurveyed and several plants were found alive, but buried in the sand.

The back of the dunes on Ramp 67, where the *Trichostema* is located.

Overall Recommendations: Monitor the new dunes for re-vegetation. The area should be monitored for the invasion of the non-native *Phragmites* and beach vitex.

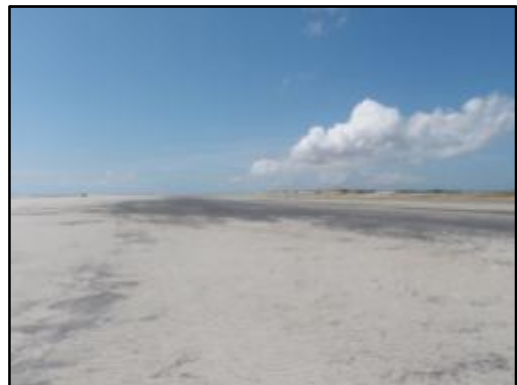
Beach on Western tip of Ocracoke Island

Overall Observations: Some sand overwash occurred in the dunes, but not a significant amount. The vegetation appears to have been minimally impacted. Aerial imagery suggests that there were significant changes to the western tip of the island; however, it does not appear to be as dramatic as on Hatteras.

Overall Recommendations: Complete aerial photo comparisons to measure exact changes to the sand flats. The area should be monitored for the invasion of the non-native *Phragmites* and beach vitex.

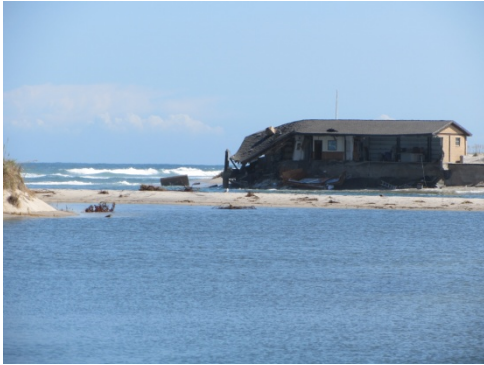
Pea Island NWR building damaged by Hurricane Irene

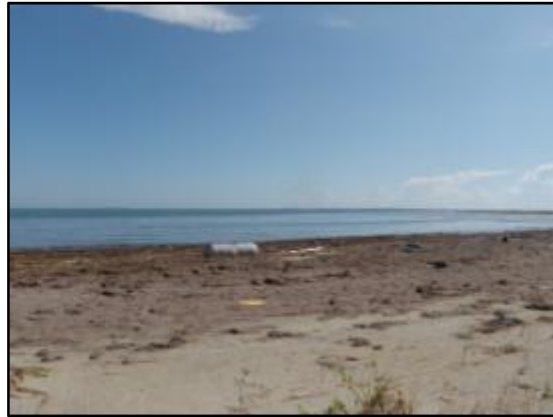
Floating trash collecting on the Eastern tip of Ocracoke Island

Overall Recommendations: The area of trash should be monitored for clean-up. The area should be monitored for the invasion of the non-native *Phragmites* and beach vitex. Also, this is a historic amaranth site and should be surveyed next year.

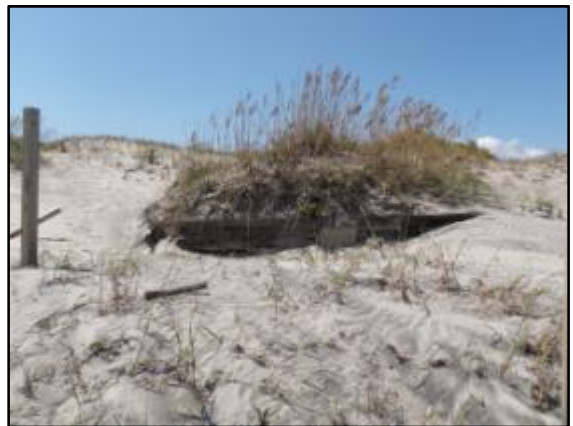
Laura A. Barnes Shipwreck

The ship was driven aground during high seas in 1921. This shipwreck was exposed and disturbed when the storm surge from Hurricane Irene washed away the protective sand dune that formed over the remains of the vessel. No historic artifacts were found associated with the remains of the ship's hull.

- Stabilize the timbers by leaving in situ and placing sand fence to allow sand to cover the shipwreck.
- Document the timbers with photography, drawings and detailed mapping of remaining ship fabric, Conduct a condition assessment into AMIS.

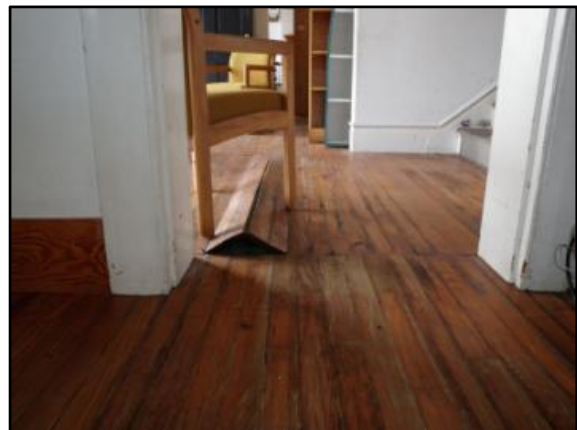
Bodie Island Keeper's Quarters

- Hatteras Double Keepers Quarters and Principle Keepers Quarter roof structure was entered into FMSS Damage Assessment
- Bodie Island Double Keepers Quarters floor damage was assessed entered into FMSS Damage Assessment

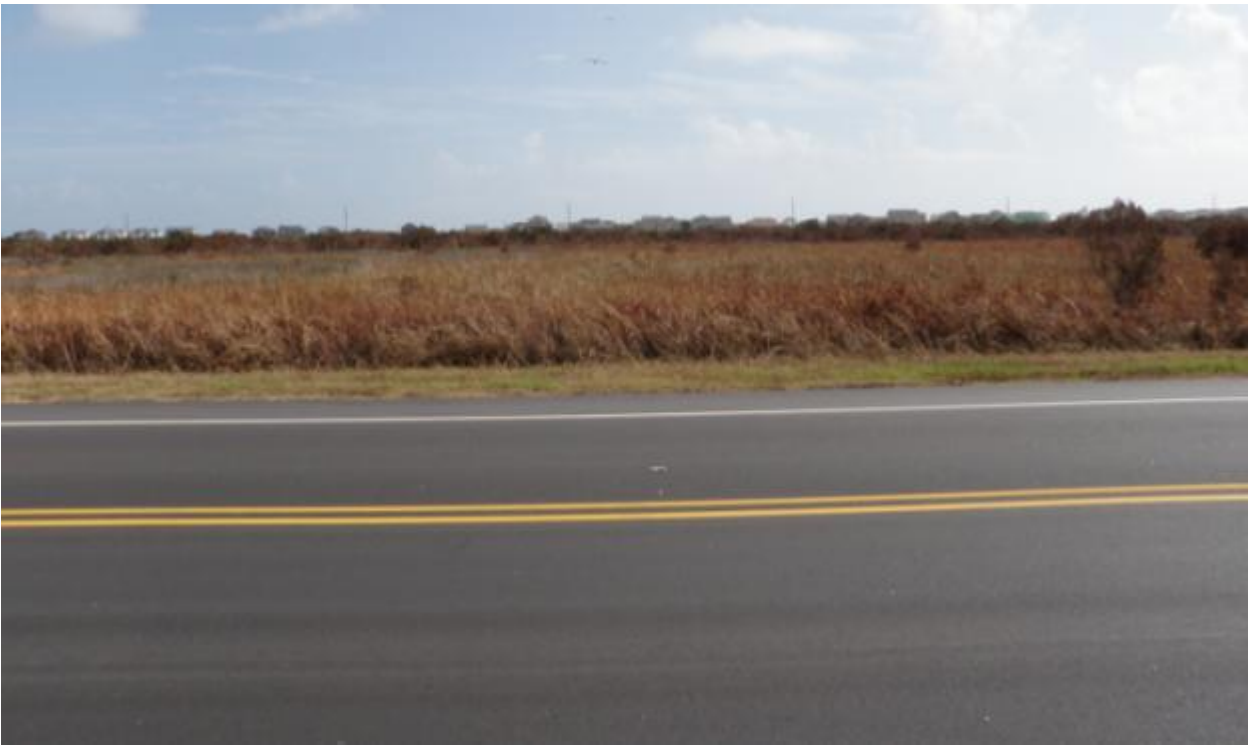
Cured grass marsh, taken from Hwy 12.

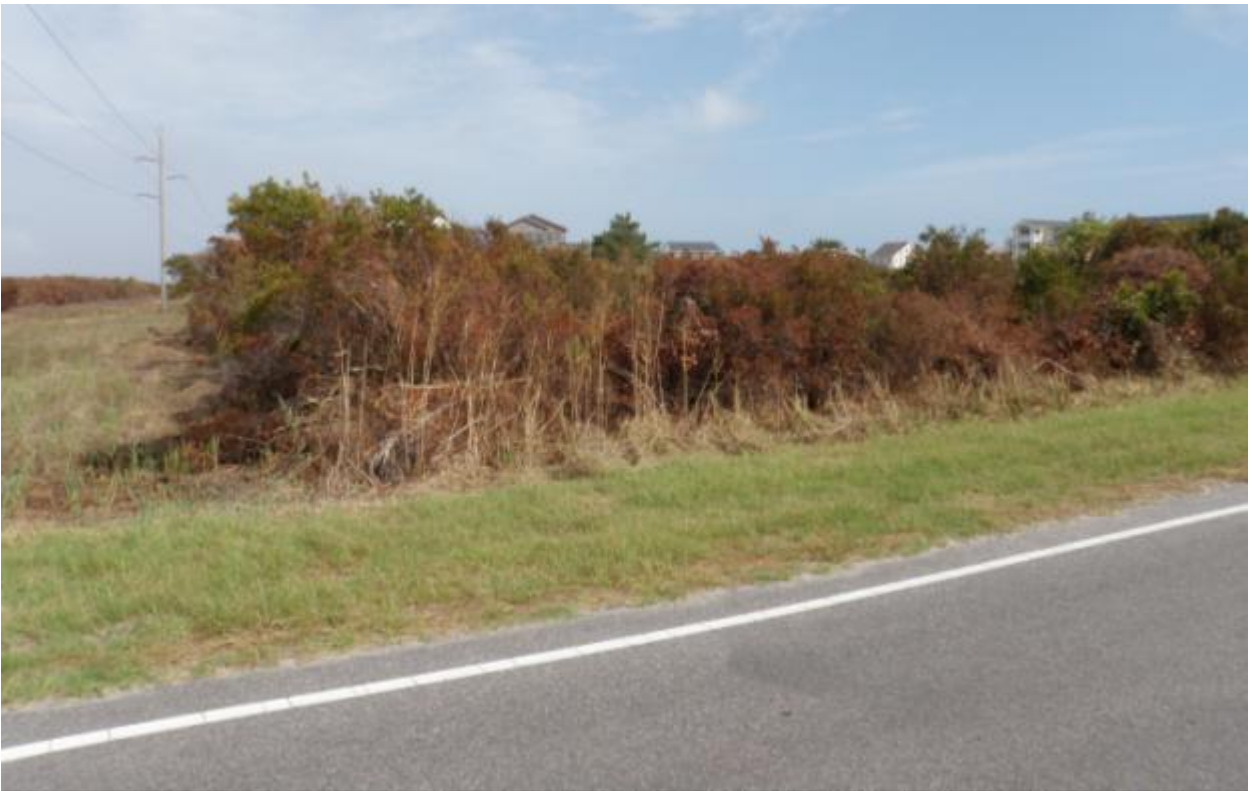
Dense shrubs, east of power line at south end of unit, only Park Service property east of the power lines in this unit.

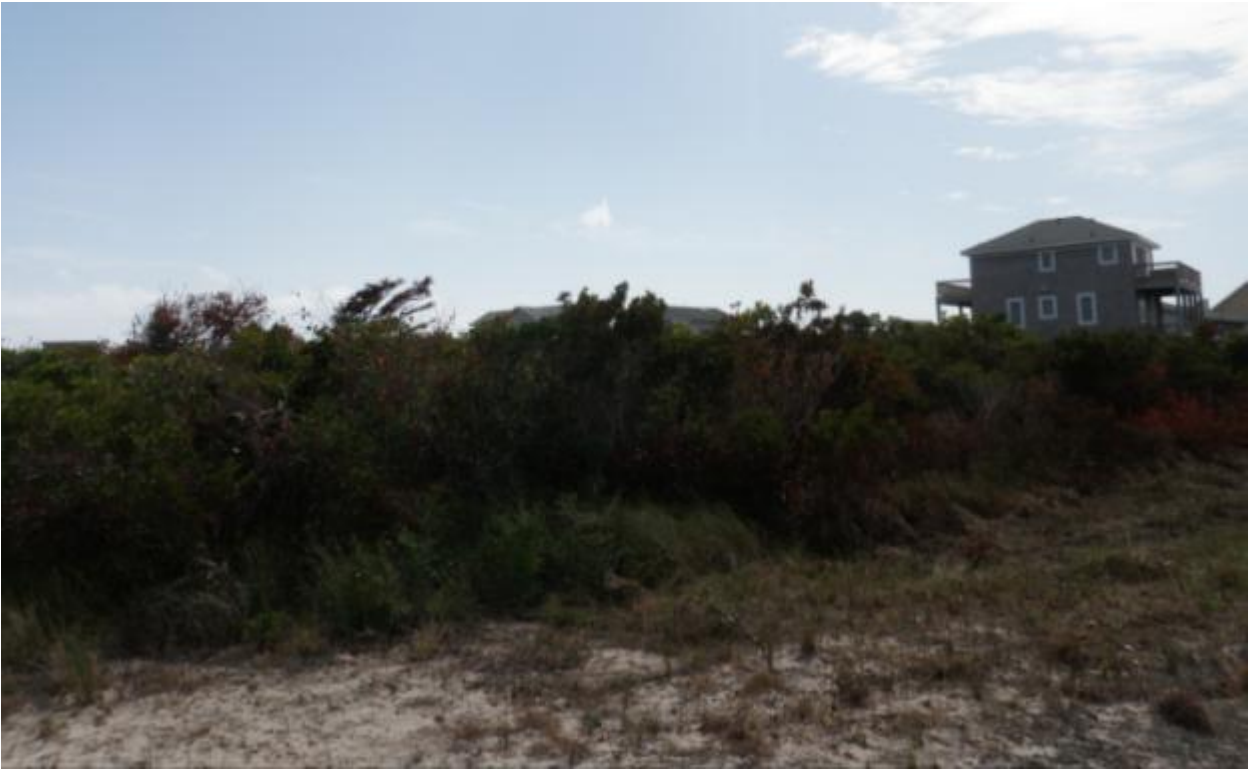
Dense shrub cover on Nags Head side of power line break

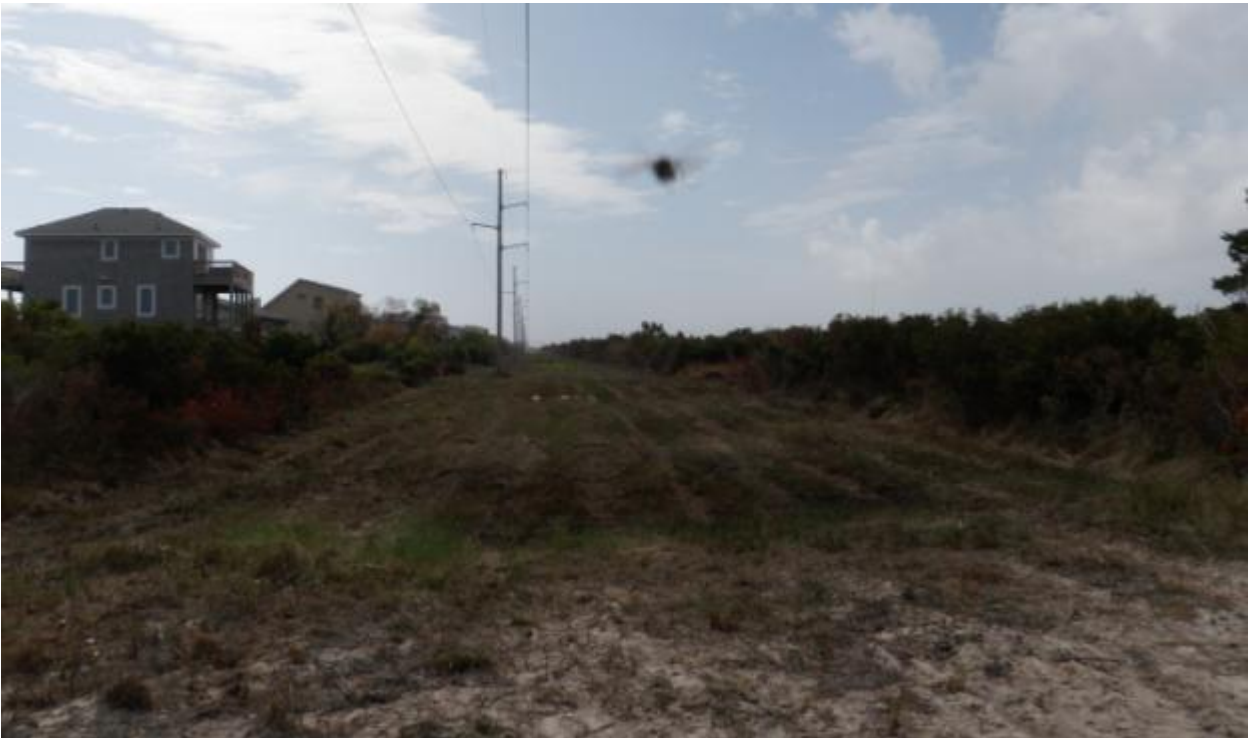
Clean fire break under power lines. This break should be maintained to be free of shrubs with short grass.

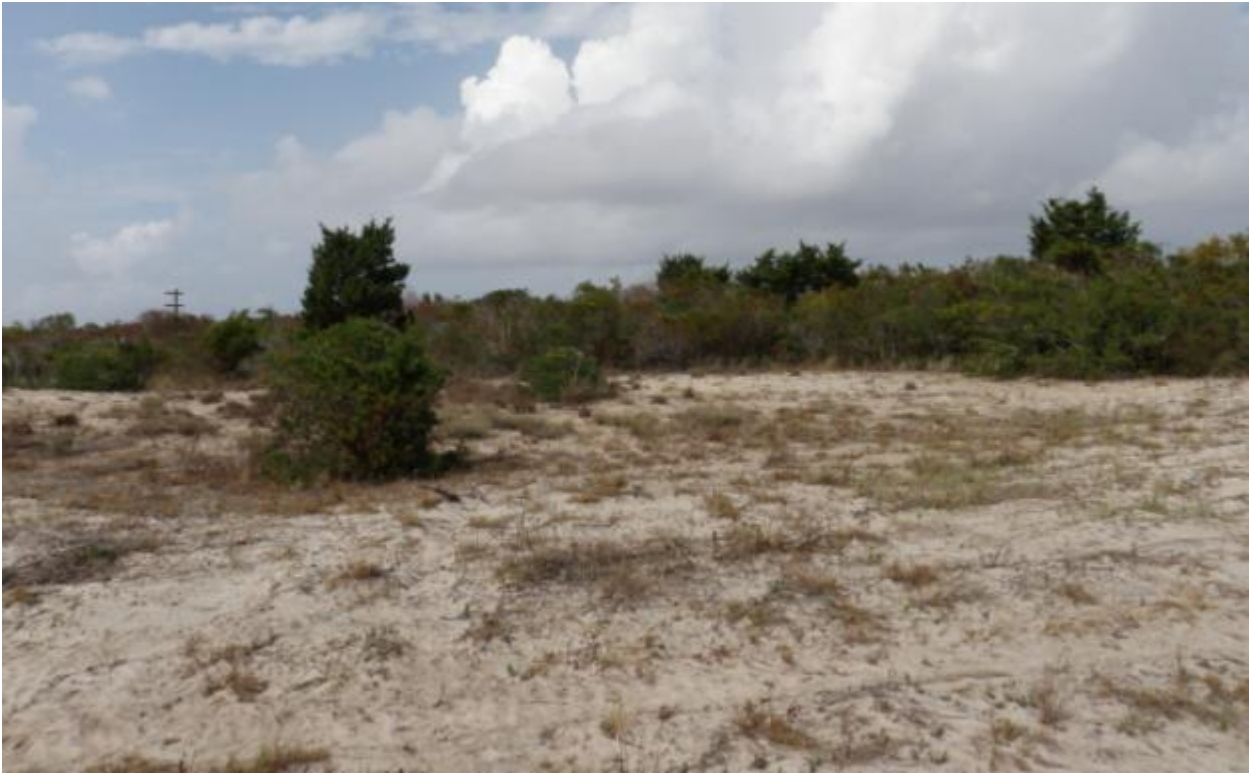
Shrub fuel loading on Park Service property, just west of the power line break.
