Proposal to Create Flow Paths through the Constructed Berm at Assateague Island National Seashore

North End Restoration Project Annual Report: 2009

Restoration of Natural Geomorphic Processes to Create Barrier Island Habitat on Assateague Island, Maryland

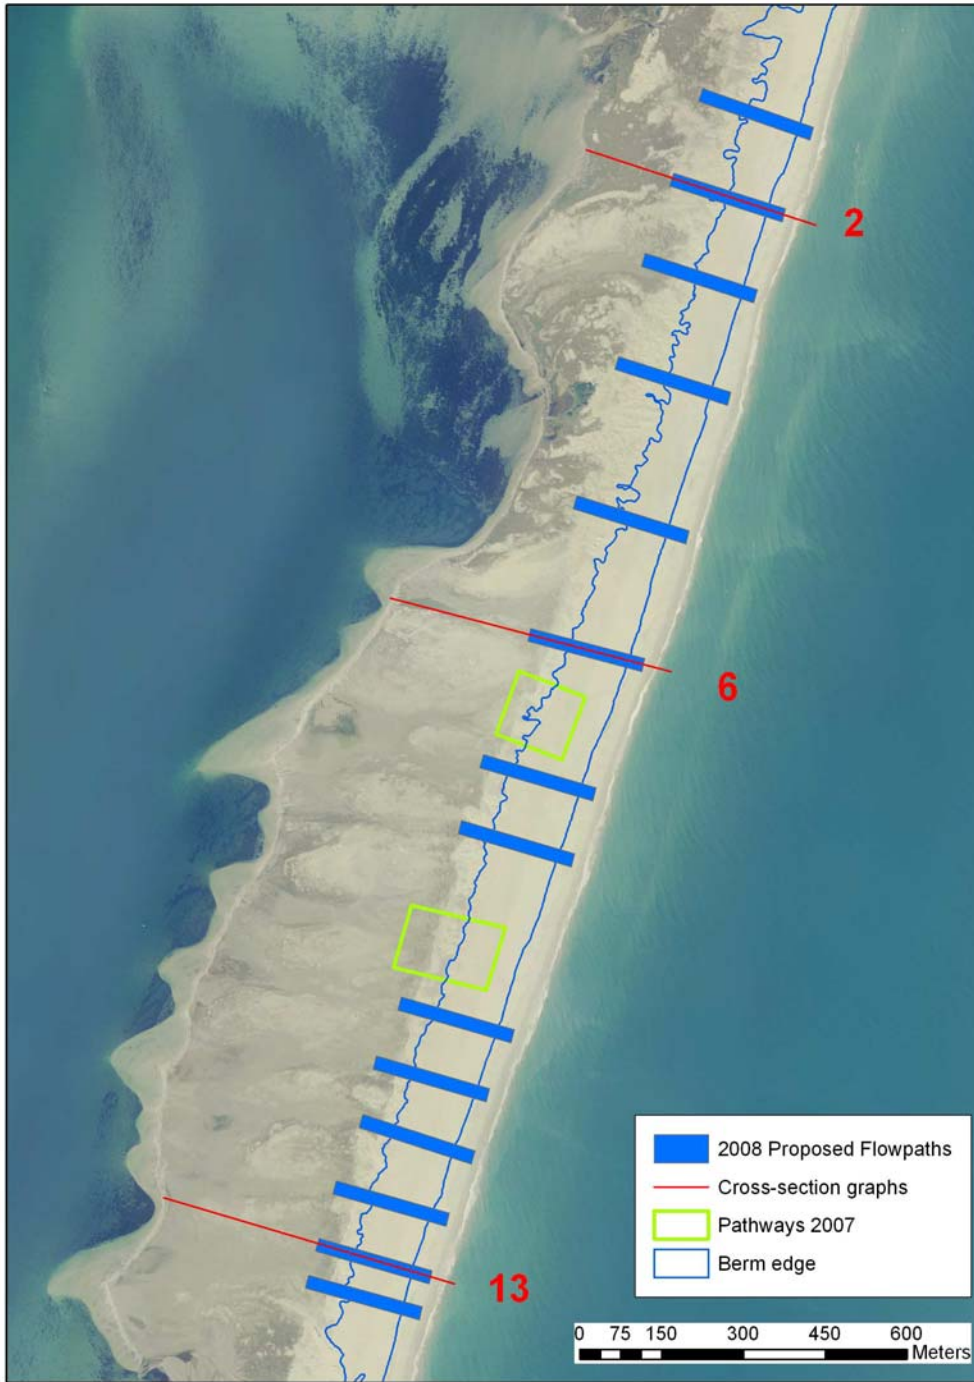
Proposed 30 m Flow Paths

Figure 1. Proposed locations for the 14 natural beach profiles, each 30 m wide (blue). The two pathways created in February 2007 are shown in green. The red lines indicate the locations of cross-island elevation profiles shown in the following figures.

We propose to create 14 flow paths, each 30 m wide, through a total of 420 m, or 17%, of the length of the existing constructed berm. The proposed locations of these flow paths (Figure 1) were chosen based on several considerations: the potential benefit to plover habitat; the distance from the edges of the constructed berm; and field observations and GIS-based identification of potential flow paths that take advantage of existing topographical features and avoid dunes and other topographic impediments. All of the 30- m-wide flow paths would be located more than 200 m from both the northern and southern limits of the constructed berm, and sand from the flow paths would remain in the immediate area. Based on post-construction survey of the previous two alterations, it is expected that sand slumping from the sides of each new flow path will extend outward up to 5 m on each side, reducing the 30 m flow path to a width of 20 m at base elevation.

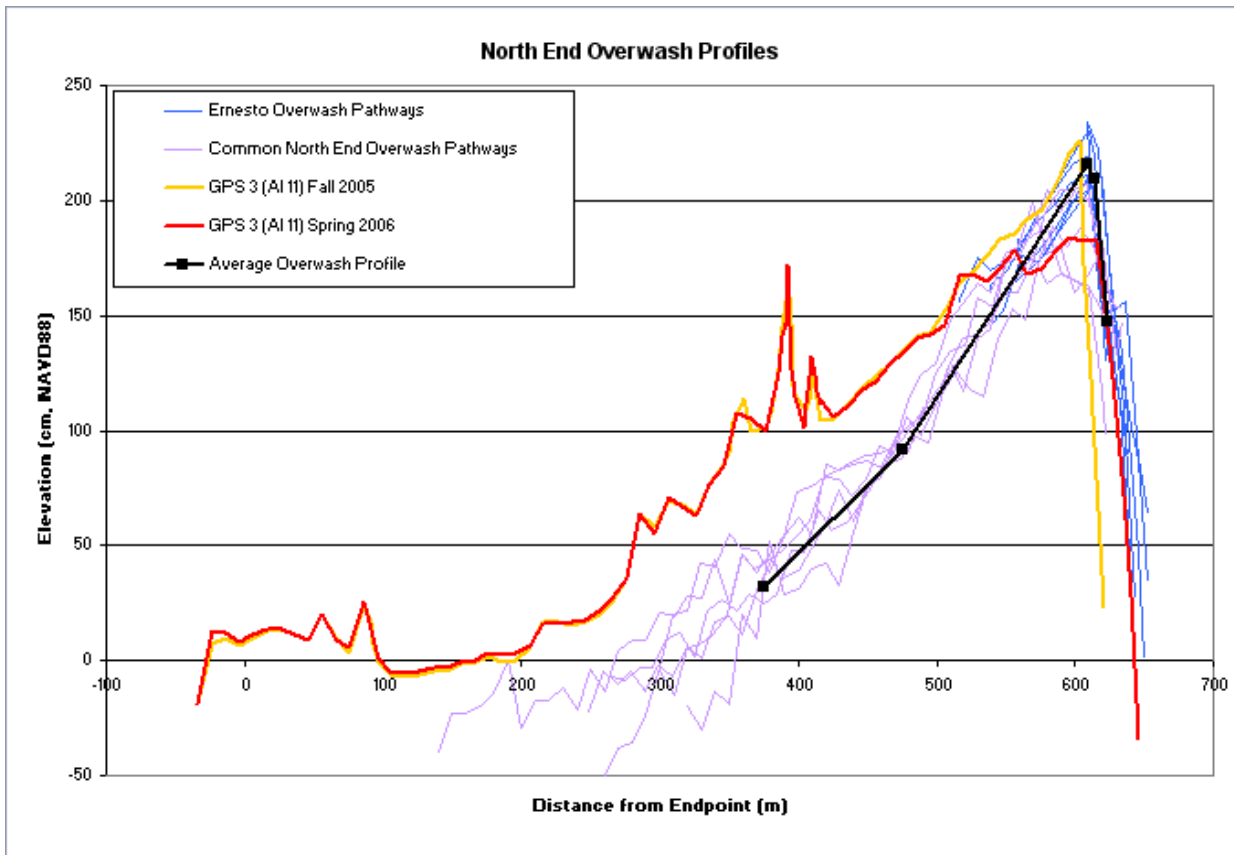
Figure 2. Idealized overwash profile (dark black line) was created based on inflection points, elevations, and slopes of typical overwash pathways along the North End of the island.

After superimposing all of these flow path profiles, we noted similarities in shape, slope, and relative elevations. We identified significant breaks in slope and found average heights for and distances between these vertices, thereby creating an idealized profile (Figure 2). The peak elevation in this idealized profile is 2.16 m NAVD88 (7.09 ft NAVD88). Figures 3 and 4 illustrate the idealized natural profile overlaid on representative cross-island profiles of the constructed berm (measured by extracting elevations from September 2005 lidar surveys).

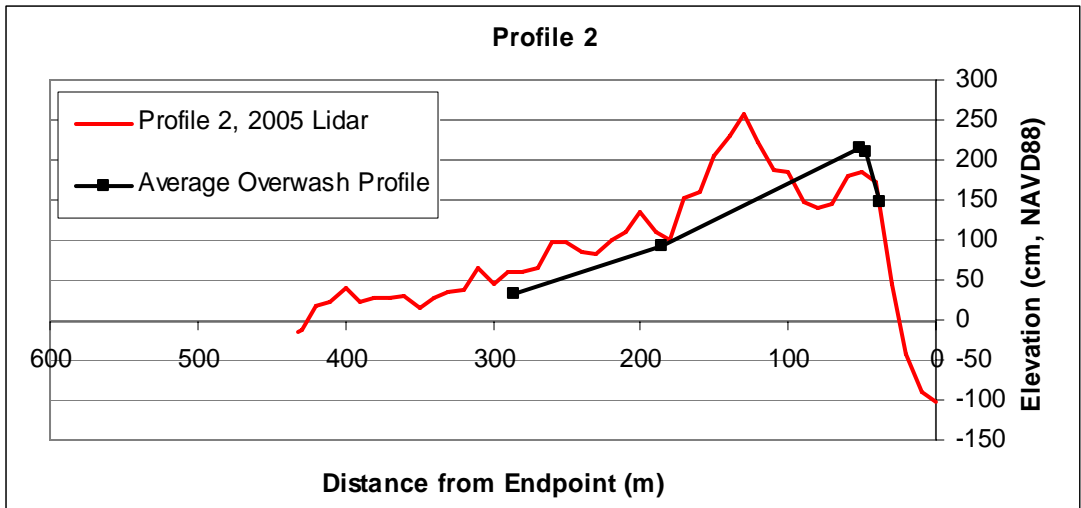
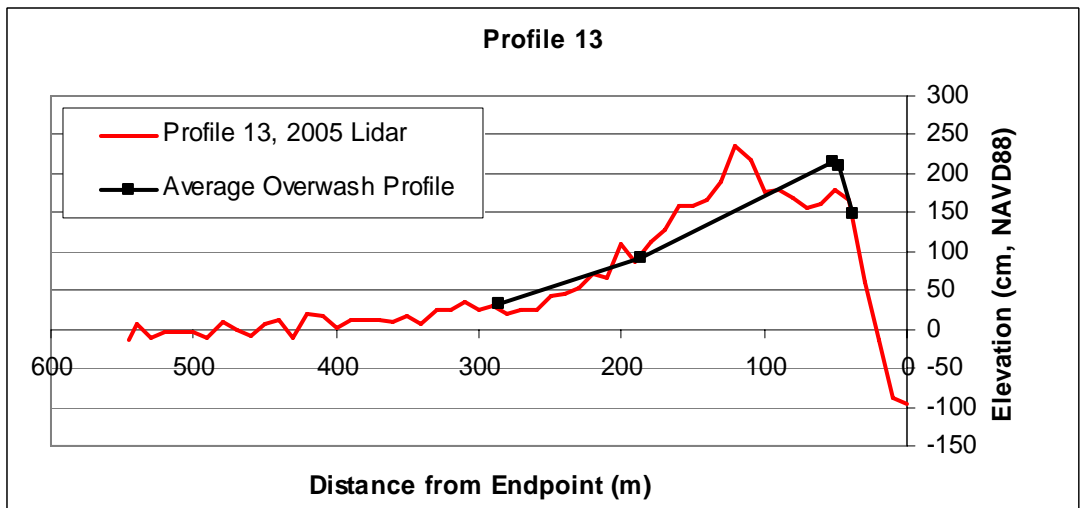
Figures 3-5. Cross-berm elevation profiles at proposed notch locations, with the idealized beach profile (black line) superimposed. Elevations are extracted from September 2005 lidar surveys.

Due to the date of the lidar data and to topographic variations within each proposed flow path location, the proposed profiles may not be replicated precisely as illustrated in the graphics, which capture only a few cross-sections of the proposed pathways.

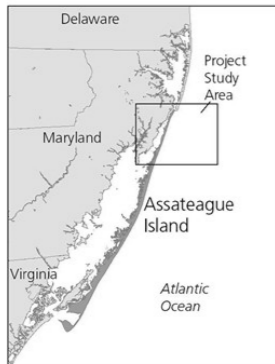
Figure 1. Assateague Island is a barrier island that extends 58 km along the coast of Maryland and Virginia.

Assateague Island National Seashore is responsible for protecting the natural resources, processes, and ecosystems of Assateague Island, a barrier island that extends 58 km along the coast of Maryland and Virginia, and is bounded to the north by the stabilized Ocean City Inlet (Figure 1).
