Resource Advisor - Final Report Hurricane Irene Cape Hatteras National Seashore

Incident Dates: Begin August 23, 2011 - September 10, 2011
Incident Name: Hurricane Irene
Incident Number: NC-CHP-110001
Location: Cape Hatteras National Seashore 35.212 N, 75.531 W
Incident Commander: Zeph Cunningham

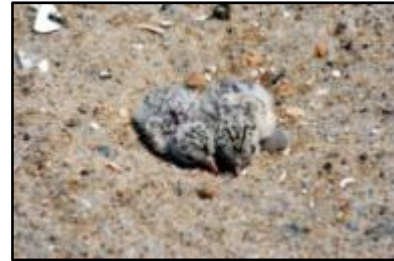
Least Tern chicks near Ramp 1

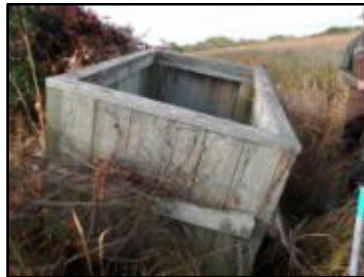
Following hurricane Irene attempts were made to locate twenty duck blinds in the Bodie Island district. Twelve of the blinds were completely swept away in the storm, one blind was found partially intact and seven were located intact.

Intact duck blind

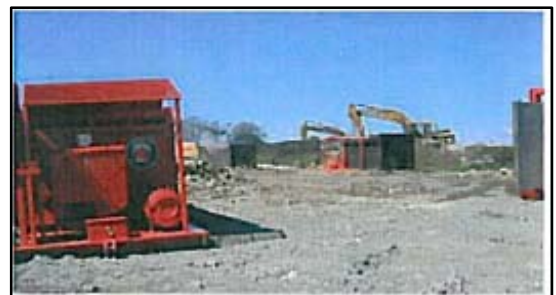
On September 2, 2011 Dare County submitted an application to use an Air Curtain Furnace (ACI) to incinerate storm debris on Hatteras Island. The proposal was to set up the furnace in the center of the Salvo Day Use Area to incinerate debris that had been collected on the island. Only vegetation and chemical free dry lumber will be burned in the ACI. This was previously done during the 2003 hurricane. Air quality and solid waste permits have been obtained from North Carolina Department of Natural Resources. The day use area will be closed to visitors for safety reason, while the operations are going. The ACI will only be operated during daylight hours and if eye level winds are less than 25mph. Concrete and non-organic debris will be staged at the site, before it is hauled off to disposal. Ash will be mixed with sand and removed from the site.

Air Curtain Furnace

When the operation is complete, the site will be scraped and seeded with a natural vegetation mix prescribed by the CAHA resource staff.

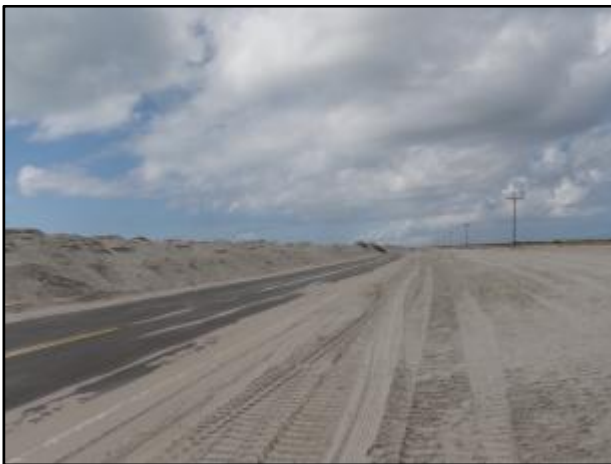
Dune replenishment was surveyed on the Northern (Eastern) portion of Ocracoke island. There was about 2 miles of road that was washed over with sand during the storm. The sand was

Dune replenishment, Ocracoke

placed back in the dunes along the south side of the road. Also, sand from the ferry dredge spoil area would be used if more sand was needed. These dunes match the height of the original dunes that survived the storm (based on comparing the new un-vegetated dunes with the vegetated dunes that were intermixed). The beach is very narrow in this stretch. In the overwash area, the vegetation on the north side of the road showed the most extensive salt burn on the island, as would be expected. For the most part the vegetation on the island showed less salt burn than the other islands, but this may be a reflection of the smaller percentage of broadleaf shrubs.

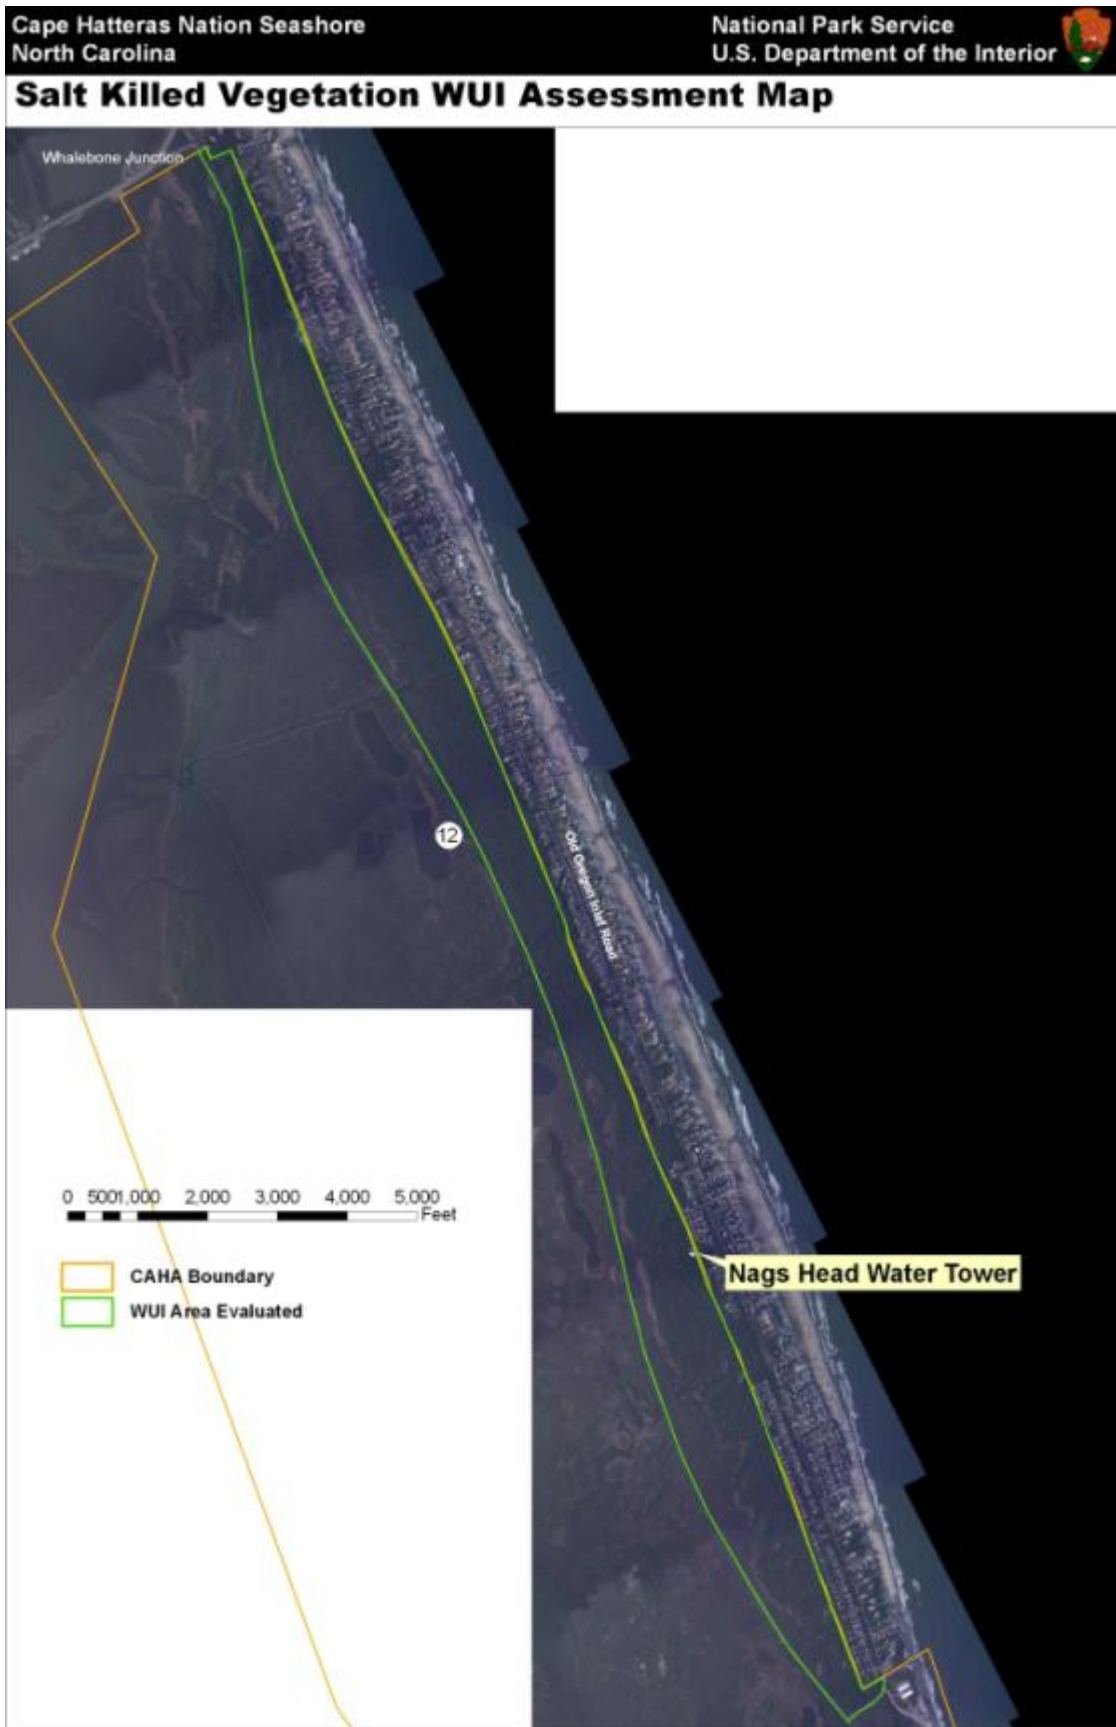
Figure 1: Map of assessed area.

The Nags Head WUI tract was evaluated for hazardous fuel conditions caused by Hurricane Irene. Hurricane Irene came with a significant sound side storm surge strong enough to carry dead grass material and miscellaneous garbage across Highway 12 into the area of concern. With the influx of fuel from the surge, the salt inundation caused significant browning of the shrubby vegetation and cured most of the grasses in the unit. This unit runs the length of Cape Hatteras National Seashore's boundary with the Village of Nag's head to the East (Figure 1). There is a large powerline that separates the village from the Seashore. The power company maintains a large mowed area under this line, creating a large (approximately 50 ft) break between a majority of the fuels and the houses. The Seashore is working with Dominion power company to enlarge this fuel break in the coming years.

There are several canals throughout the unit, but none connect the East and West ends of the unit. Additional fuel breaks should be installed off the canals to dissect the unit. These breaks will provide more options for managing wildfires, without having to impact the entire four miles of houses. Future prescribed burns are also recommended to reduce fuel loading, allowing easier control of potential wildfires.
